Blackfoot River Total Maximum Daily Load Implementation Plan for Agriculture

Developed for the Idaho Department of Environmental Quality

**Ben Evans, Amy Jenkins, and Karie Pappani
Idaho Association of Soil Conservation Districts**

February 2005

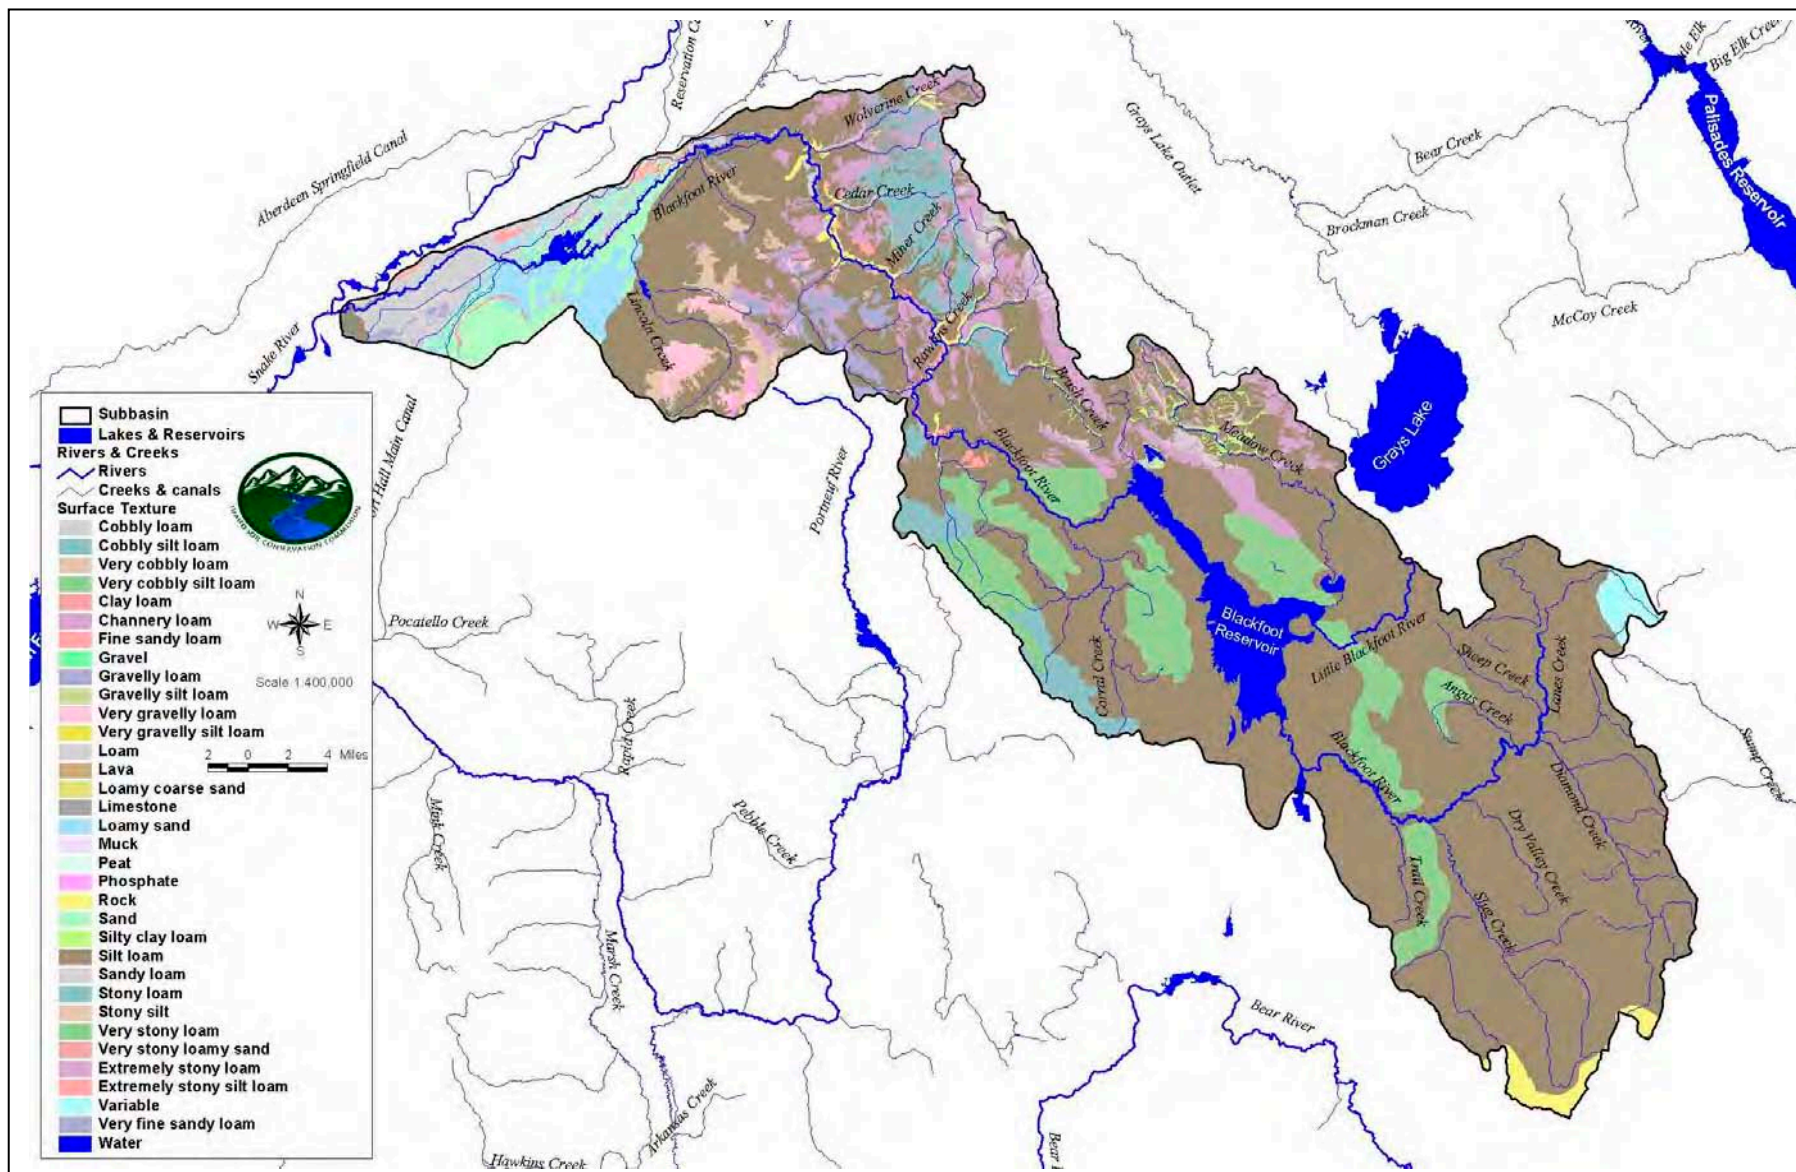
Figure 3. Soil Surface Texture in the Blackfoot River Subbasin

The Soil Survey of Bingham Area, Idaho was published in 1973 by the US Department of Agriculture (USDA) Soil Conservation Service (SCS) and covers about 23% of the subbasin. In addition to the Bingham Area survey, the SCS published the Soil Survey of Fort Hall Area in 1977 and covers 18% of the subbasin. There is no published soil survey in Caribou County. Soils in the subbasin are predominantly silt loams on 4 to 20% slopes, as shown in Table 1 and Figure 3.

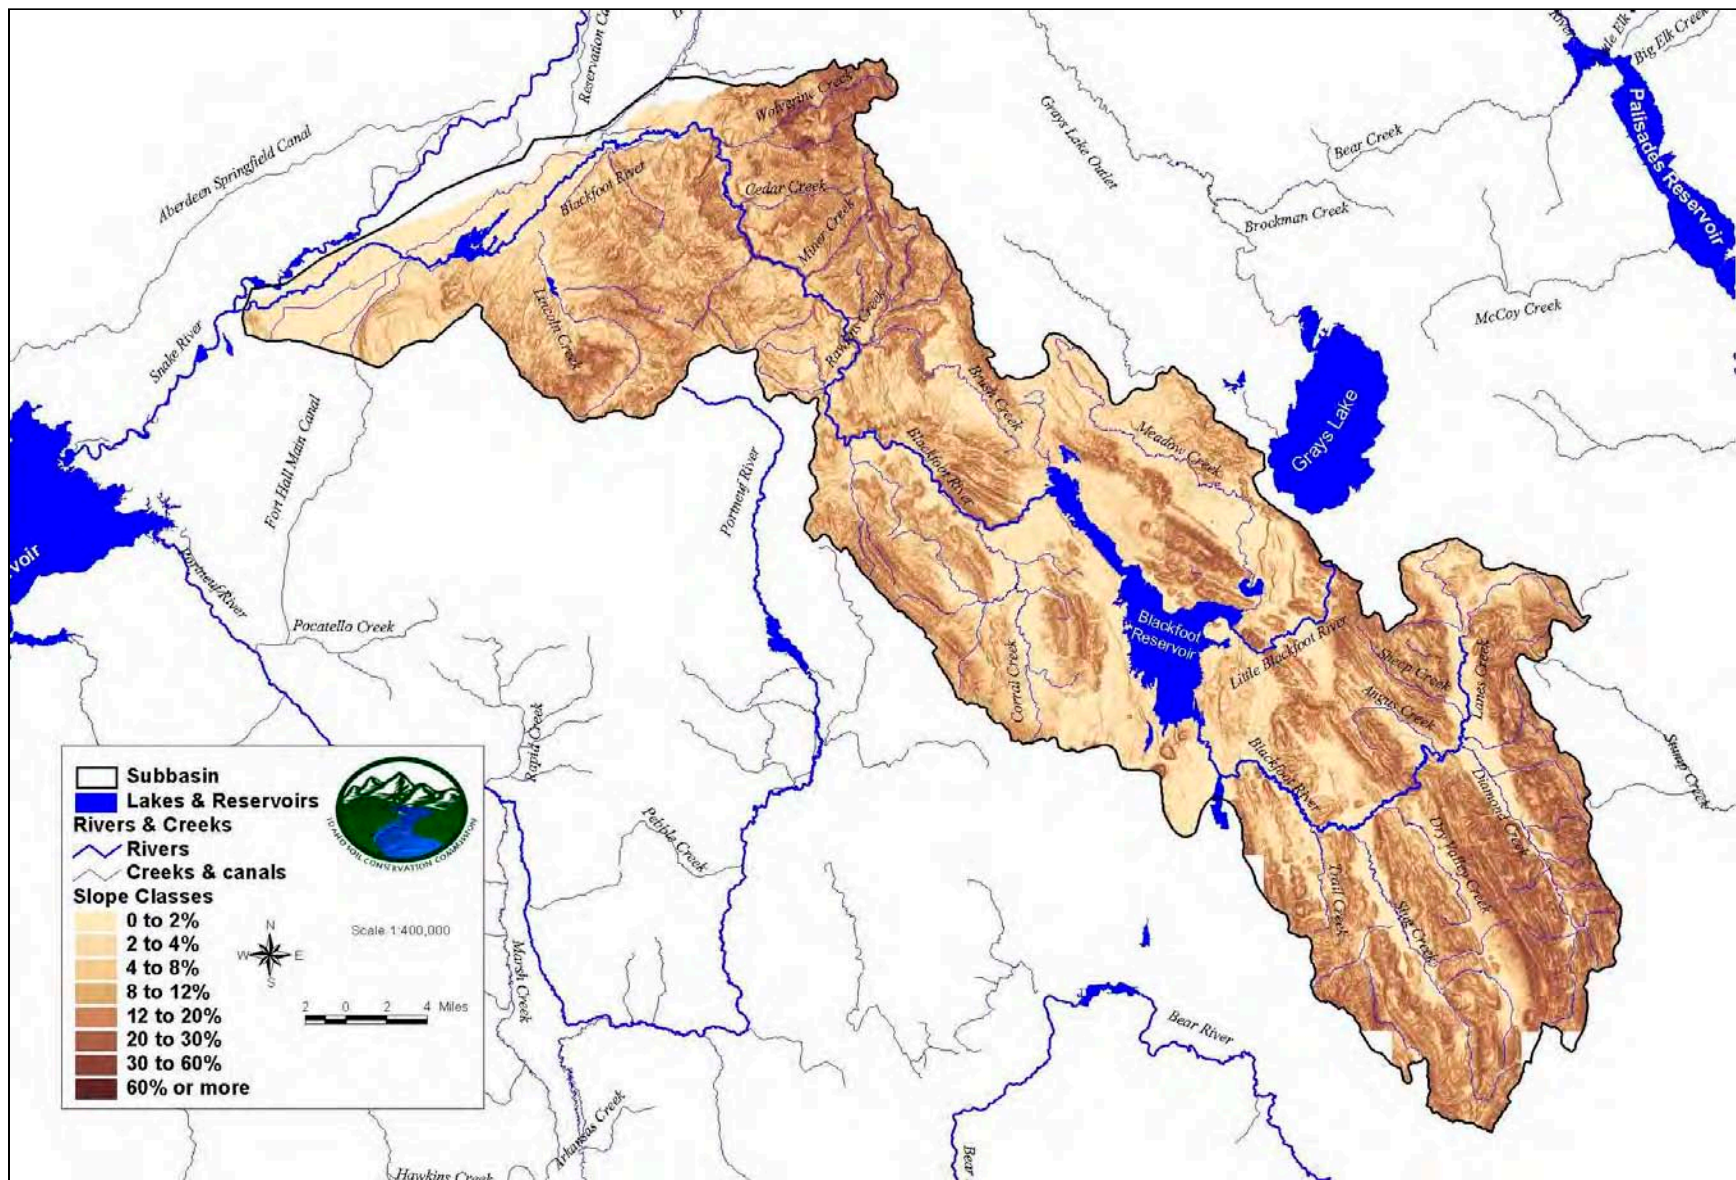
Figure 5. Slope Classes in the Blackfoot River Subbasin

The subbasin is oblong, 66 miles wide and 20 miles long. The subbasin drains 699,489 acres or 1,093 square miles. Elevations range from 8,975 feet at an unnamed peak on Dry Ridge to 4,450 feet elevation where it enters the Snake River north of Ferry Butte. Almost 60% of the subbasin's elevations occur between 6,000 and 7,000 feet. About 21% of the subbasin is flat with slopes less than 2%. Thirty percent of its slopes are gentle, from 2% to 8%. The residual 49% has slopes greater than 8%, shown in Figure 5.

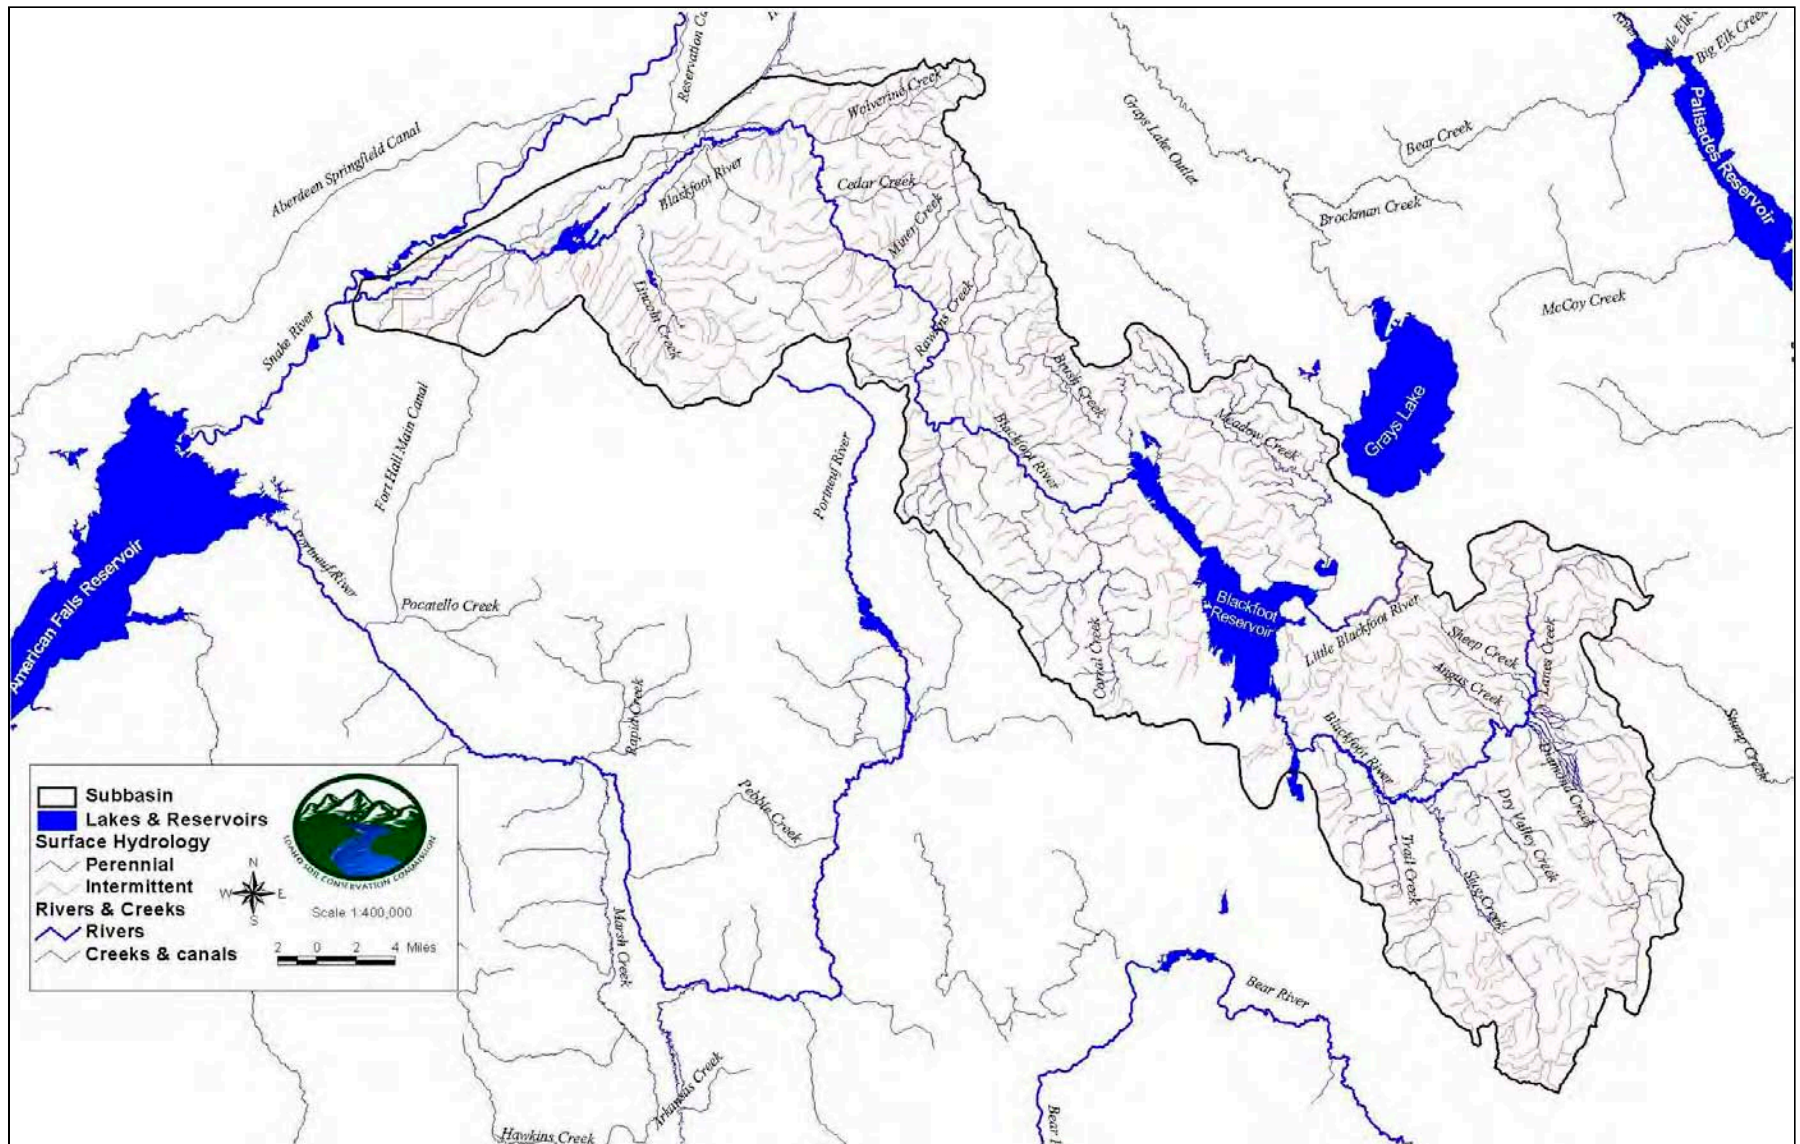
Figure 6. Surface Hydrology in the Blackfoot River Subbasin

The subbasin has 419 miles of perennial streams, 101 miles of intermittent streams, and 96 miles of canals, shown in Figure 6. Major tributaries are the Little Blackfoot River, Angus, Brush, Corral, Diamond, Dry Valley, Lanes, Meadow, Trail, and Slug creeks. The watersheds are shown in Figure 7.

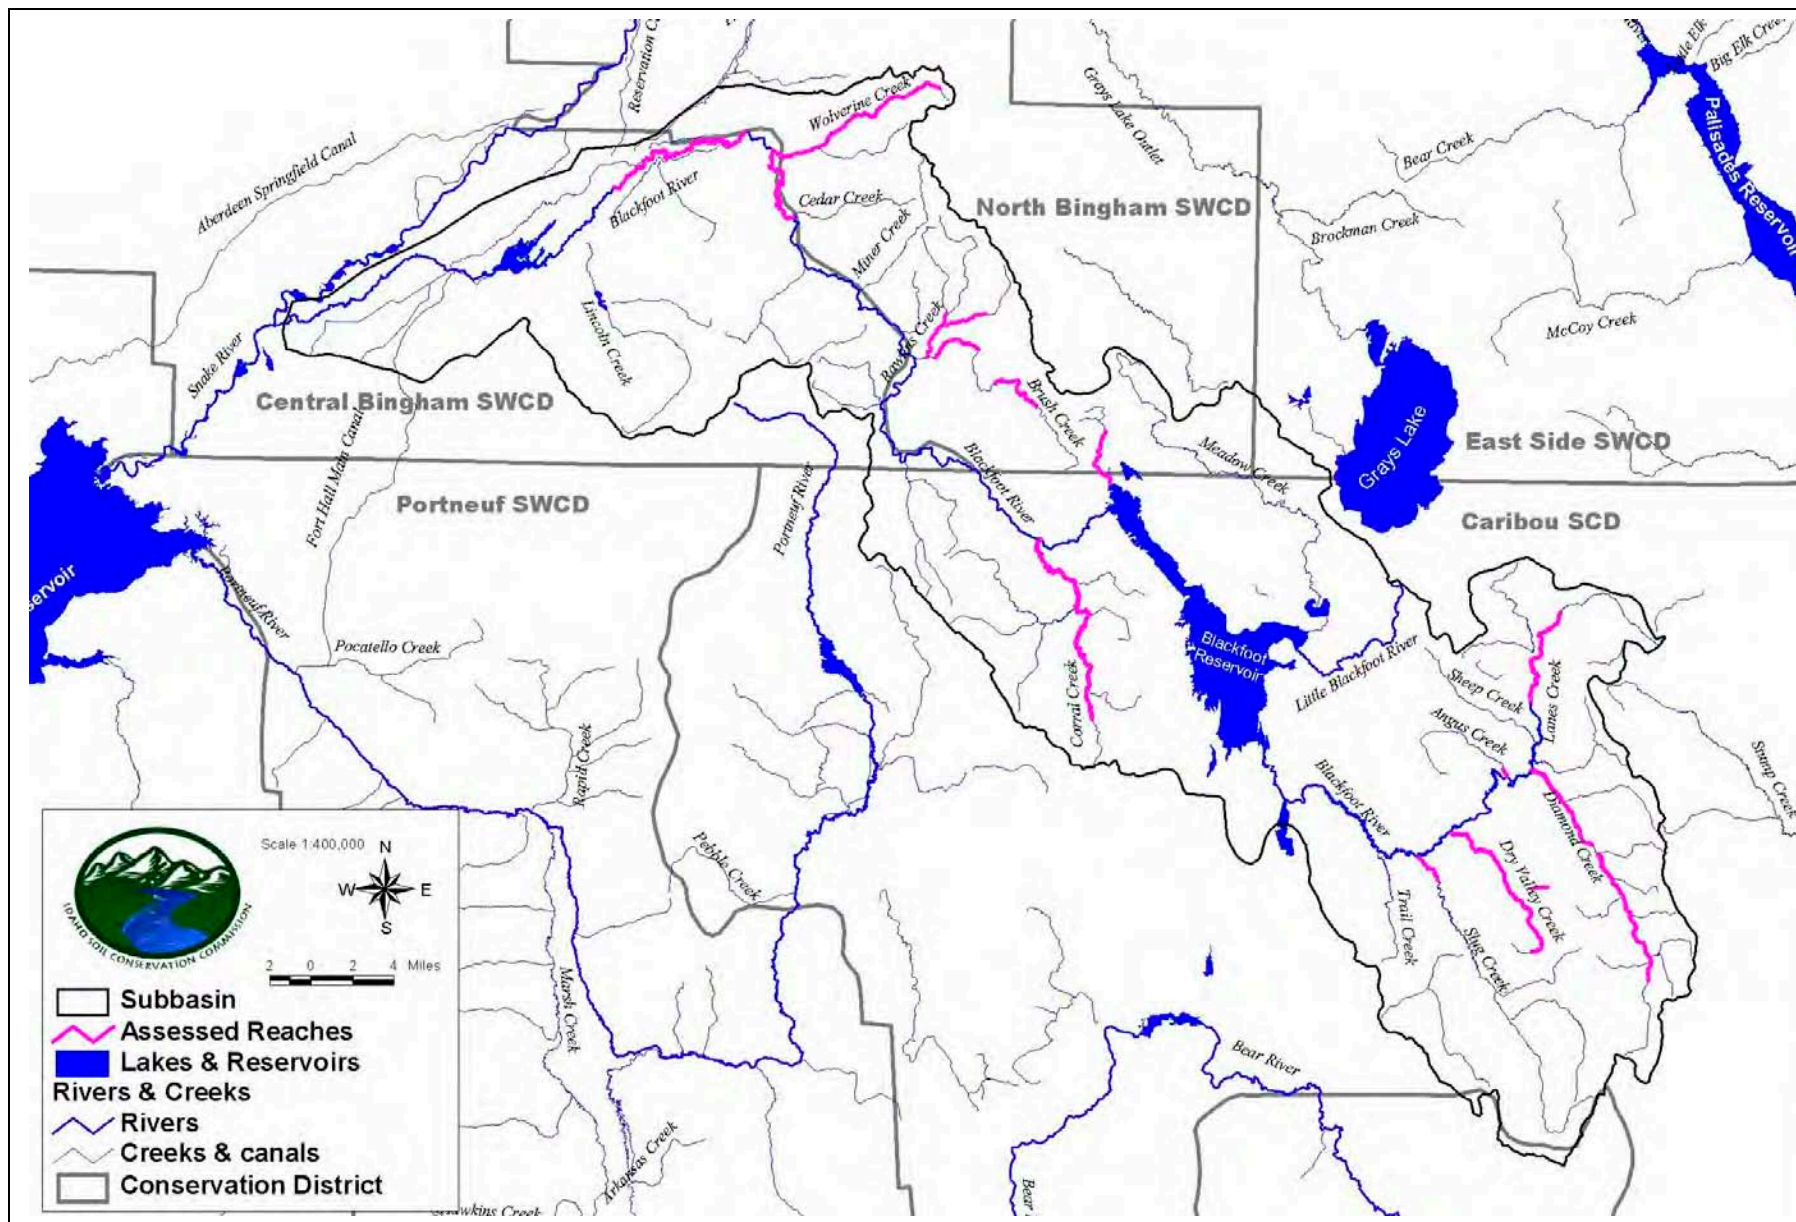
Figure 13. Assessed Reaches in the Blackfoot River Subbasin

From 1997 to 2000, seventy reaches were assessed on approximately 85 miles of rivers and creeks in the Blackfoot River subbasin, shown in Figure 13. BRWC, ISCC, IDEQ, IDL, BLM, IDFG, FS, and NRCS staff assessed where permission was granted by the landowners. The teams didn't assess where permission wasn't granted. They completed field sheets at each reach. Results are listed in Table 10.

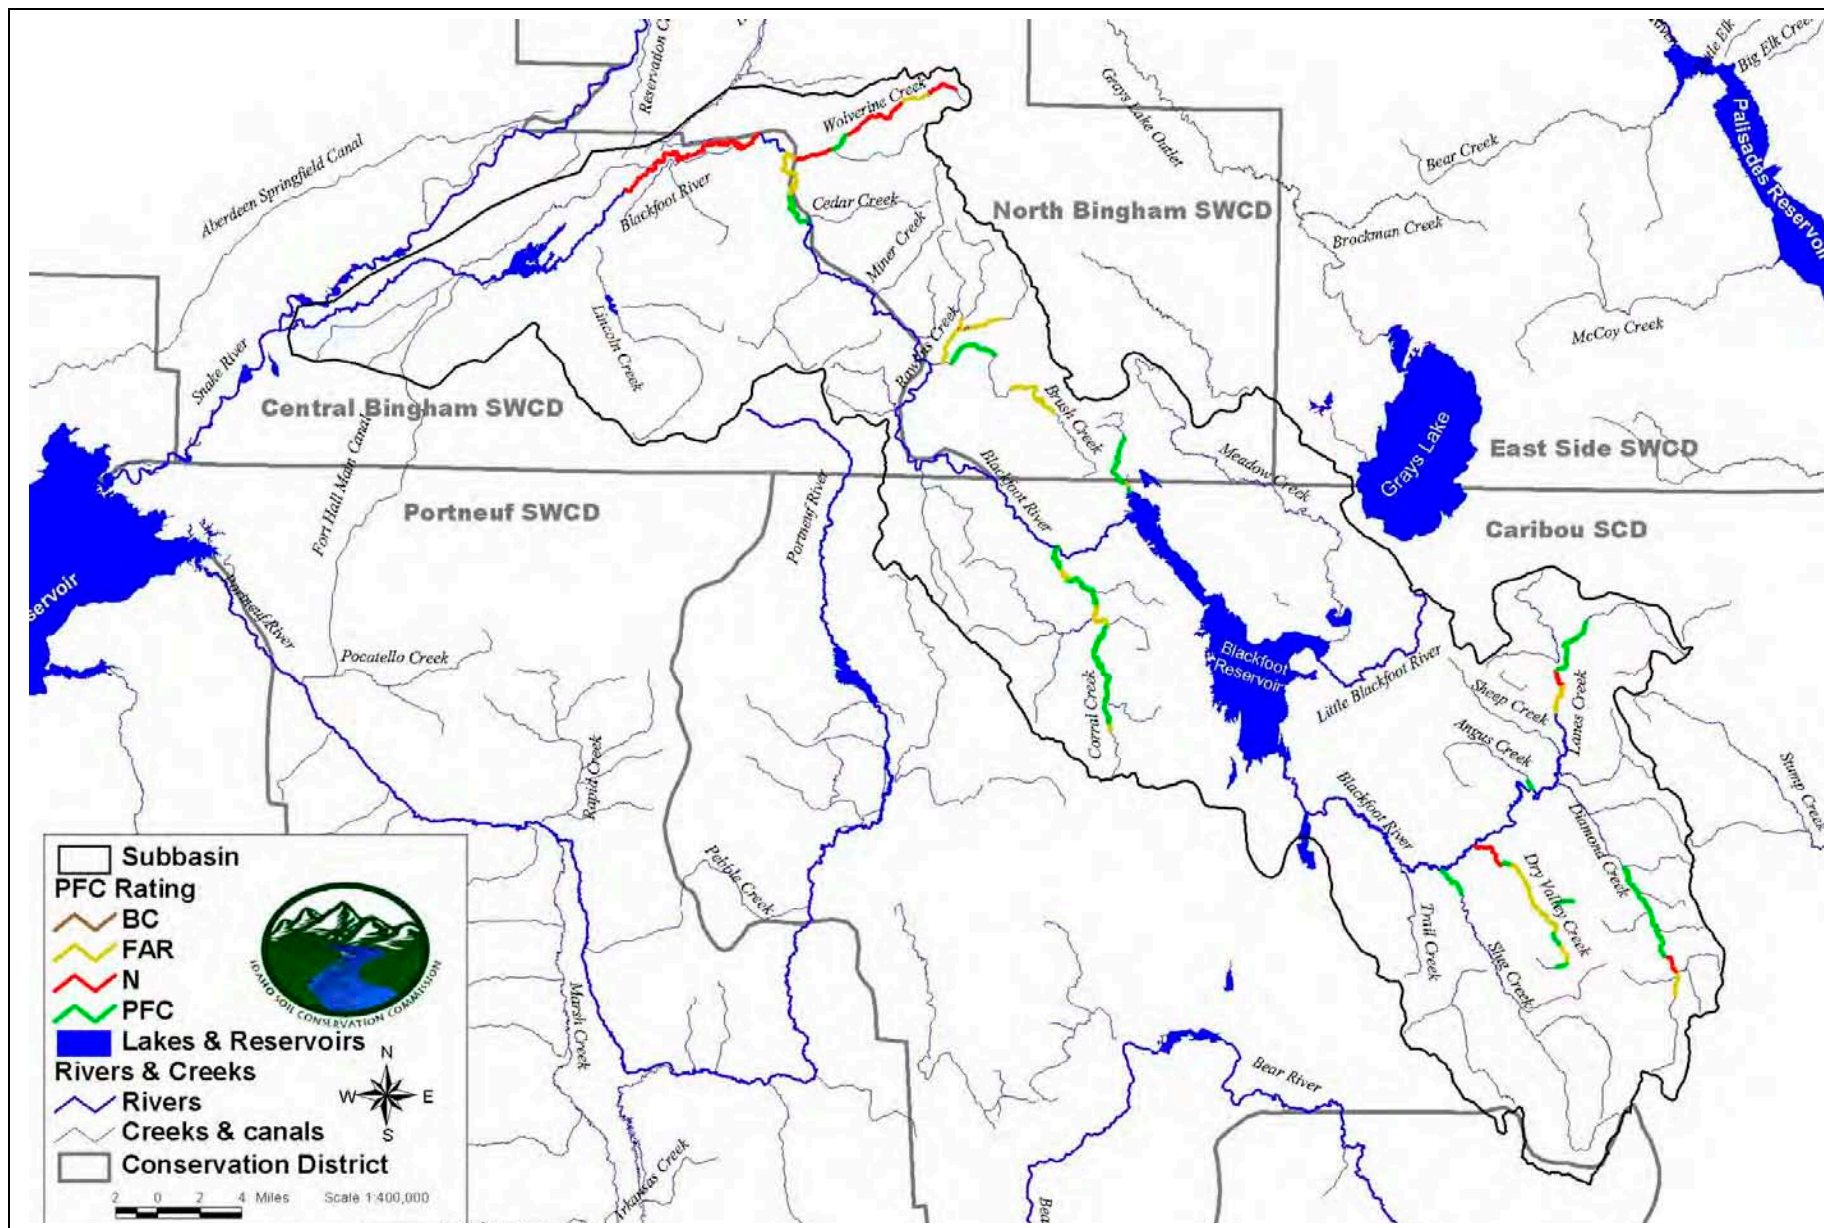
Figure 14. PFC Status of Assessed Reaches in the Blackfoot River Subbasin

The teams found 44% or 35 miles of the assessed reaches were at proper functioning condition (PFC). About 33% or 26 miles of reaches were found to be functional at risk (FAR). While 23% or 18 miles of reaches were rated as nonfunctional (N). Those results are shown in Figure 14.

Nonfunctional reaches include BR-J1, BR-P1, BR-R1, DC7, DVC1, HC1, LC6, WC3, WC4, WC7, WC8, and WC10. These reaches tended to have higher stream instability and moderate to severe erosion conditions. Unstable reaches (<50% stable) included; BC4, BC6, BC7, BR-R1, BR-P1, BR-C3, DC1, DC9, HC2, WC3, and WC8. Severely eroding reaches were BR-P1, BR-R1, BC4, BC7, and DC7.

Reaches rated as functional at risk include; BC4, BC6, BC7, BR-C2, BR-C3, CC2, CC6, CC7, CC12b, DC8, DVC6, DVC3, DVC4, HC2, HC5, HC6, HC7, LC4, LC5, PC2, RC1, RC2, WC1, and WC9. These reaches vary greatly in ranges of streambank stability, erosion condition, and stream types.

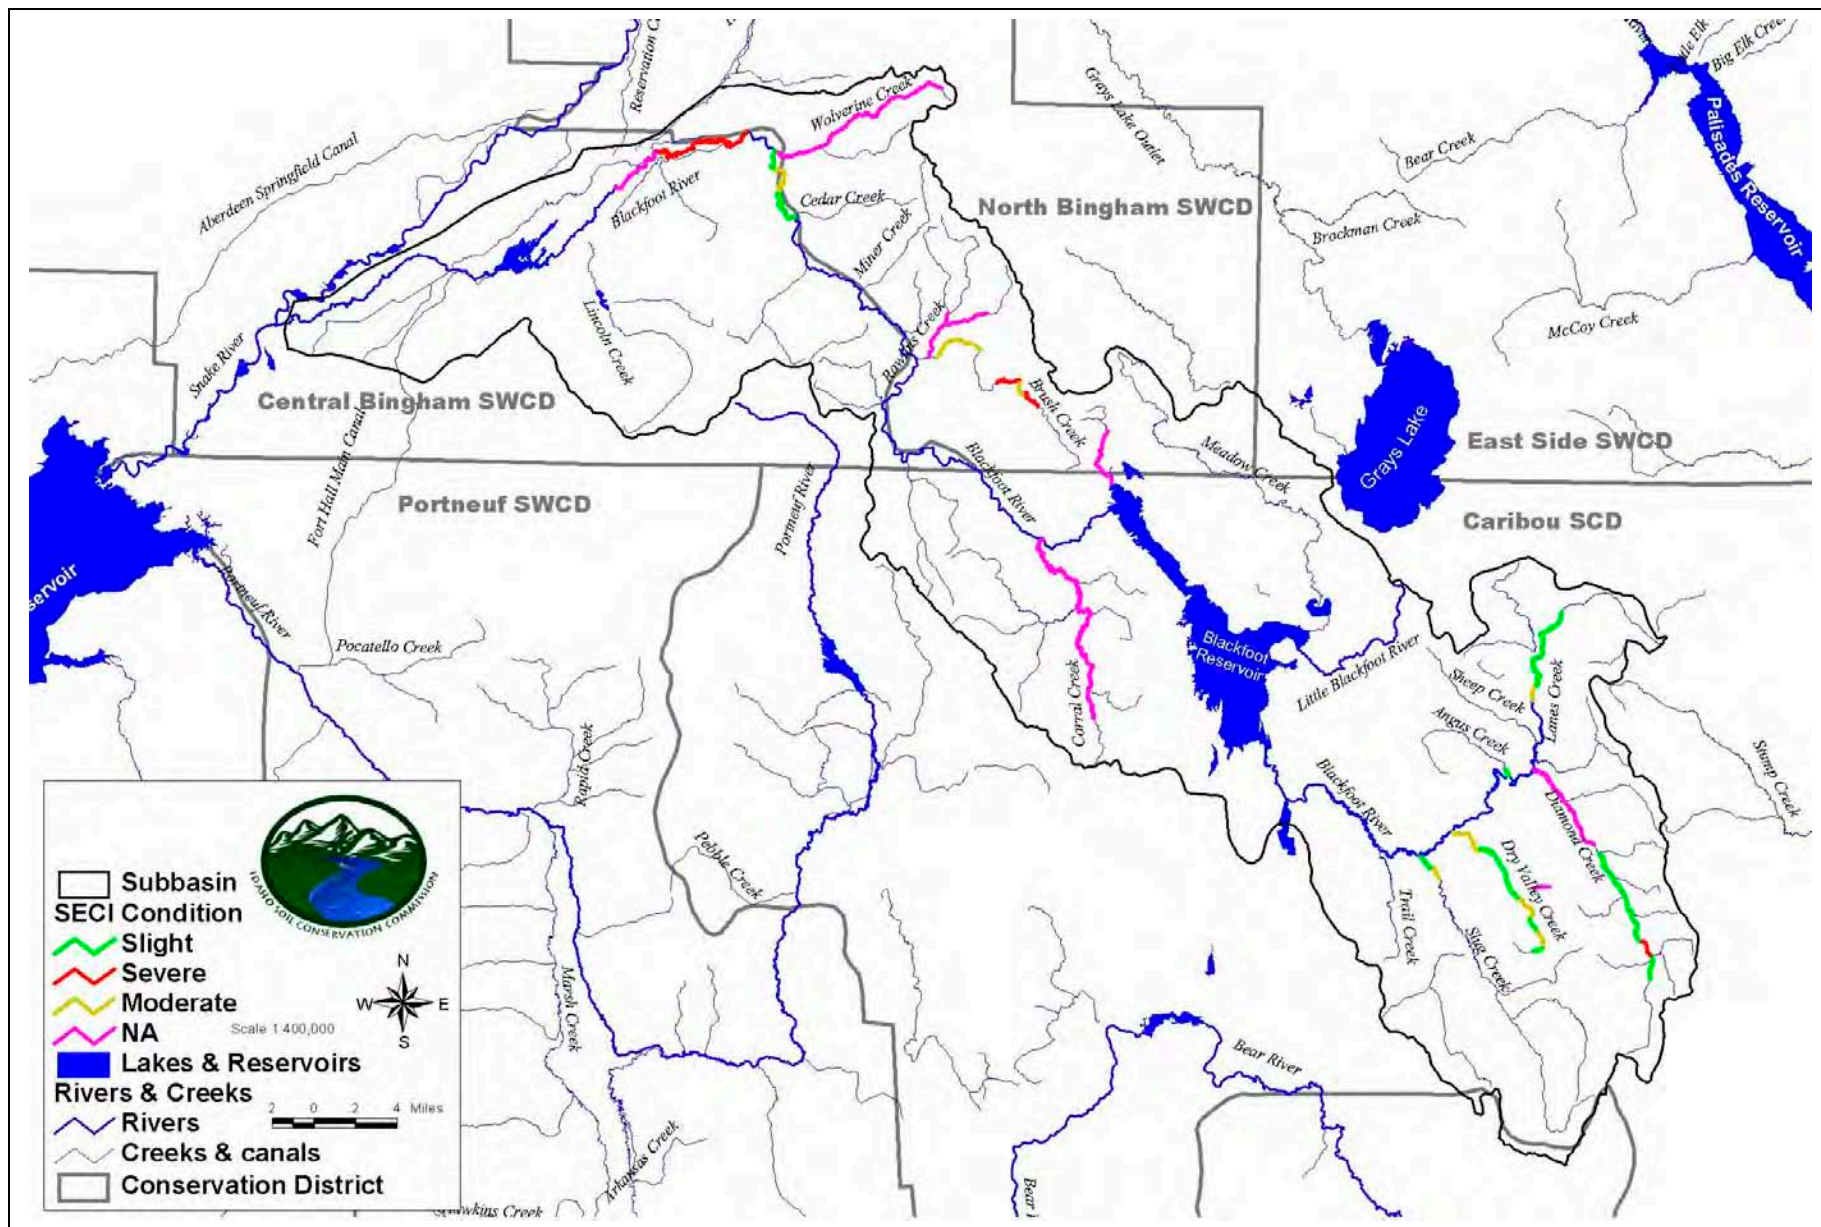
Figure 17. SECI Condition of Assessed Reaches in the Blackfoot River Subbasin

SECI results show 54% or 24 miles of assessed reaches had slight erosion. While 26% or 11 miles rated in moderate erosion condition and 20% or 9 miles rated in the severe category. SECI reach conditions and total scores are shown in Figures 17 and 18.

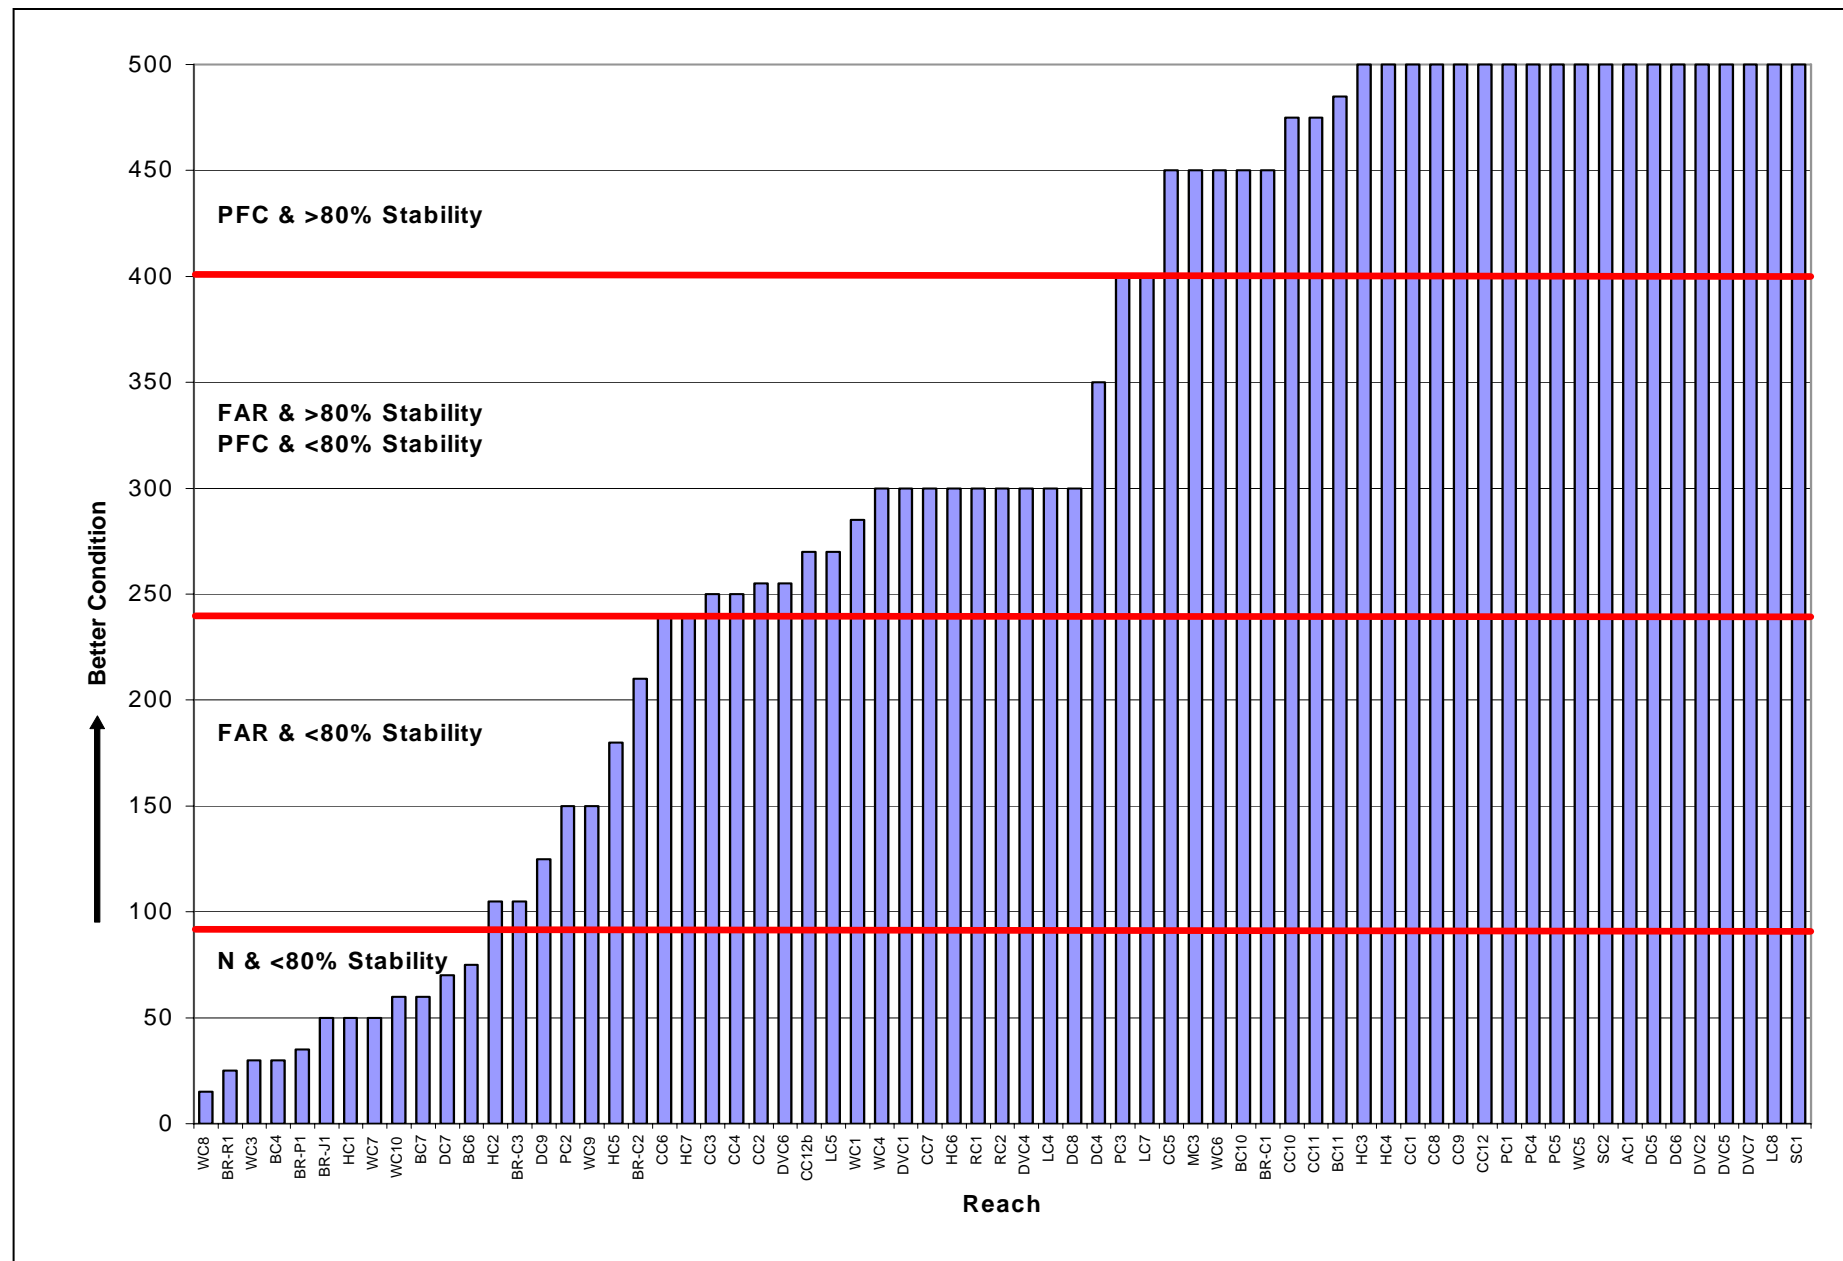
Figure 19. Streambank Stability and PFC Combined Scores of Assessed Reaches in the Blackfoot River Subbasin

As shown in Figure 19, when PFC and streambank stability values are combined, the worst reaches occur on the lower Blackfoot River, Brush and Wolverine creeks. Figure 20 shows reaches in the Blackfoot subbasin in the middle grouping when comparing erosion categories to other eastern Idaho watersheds.

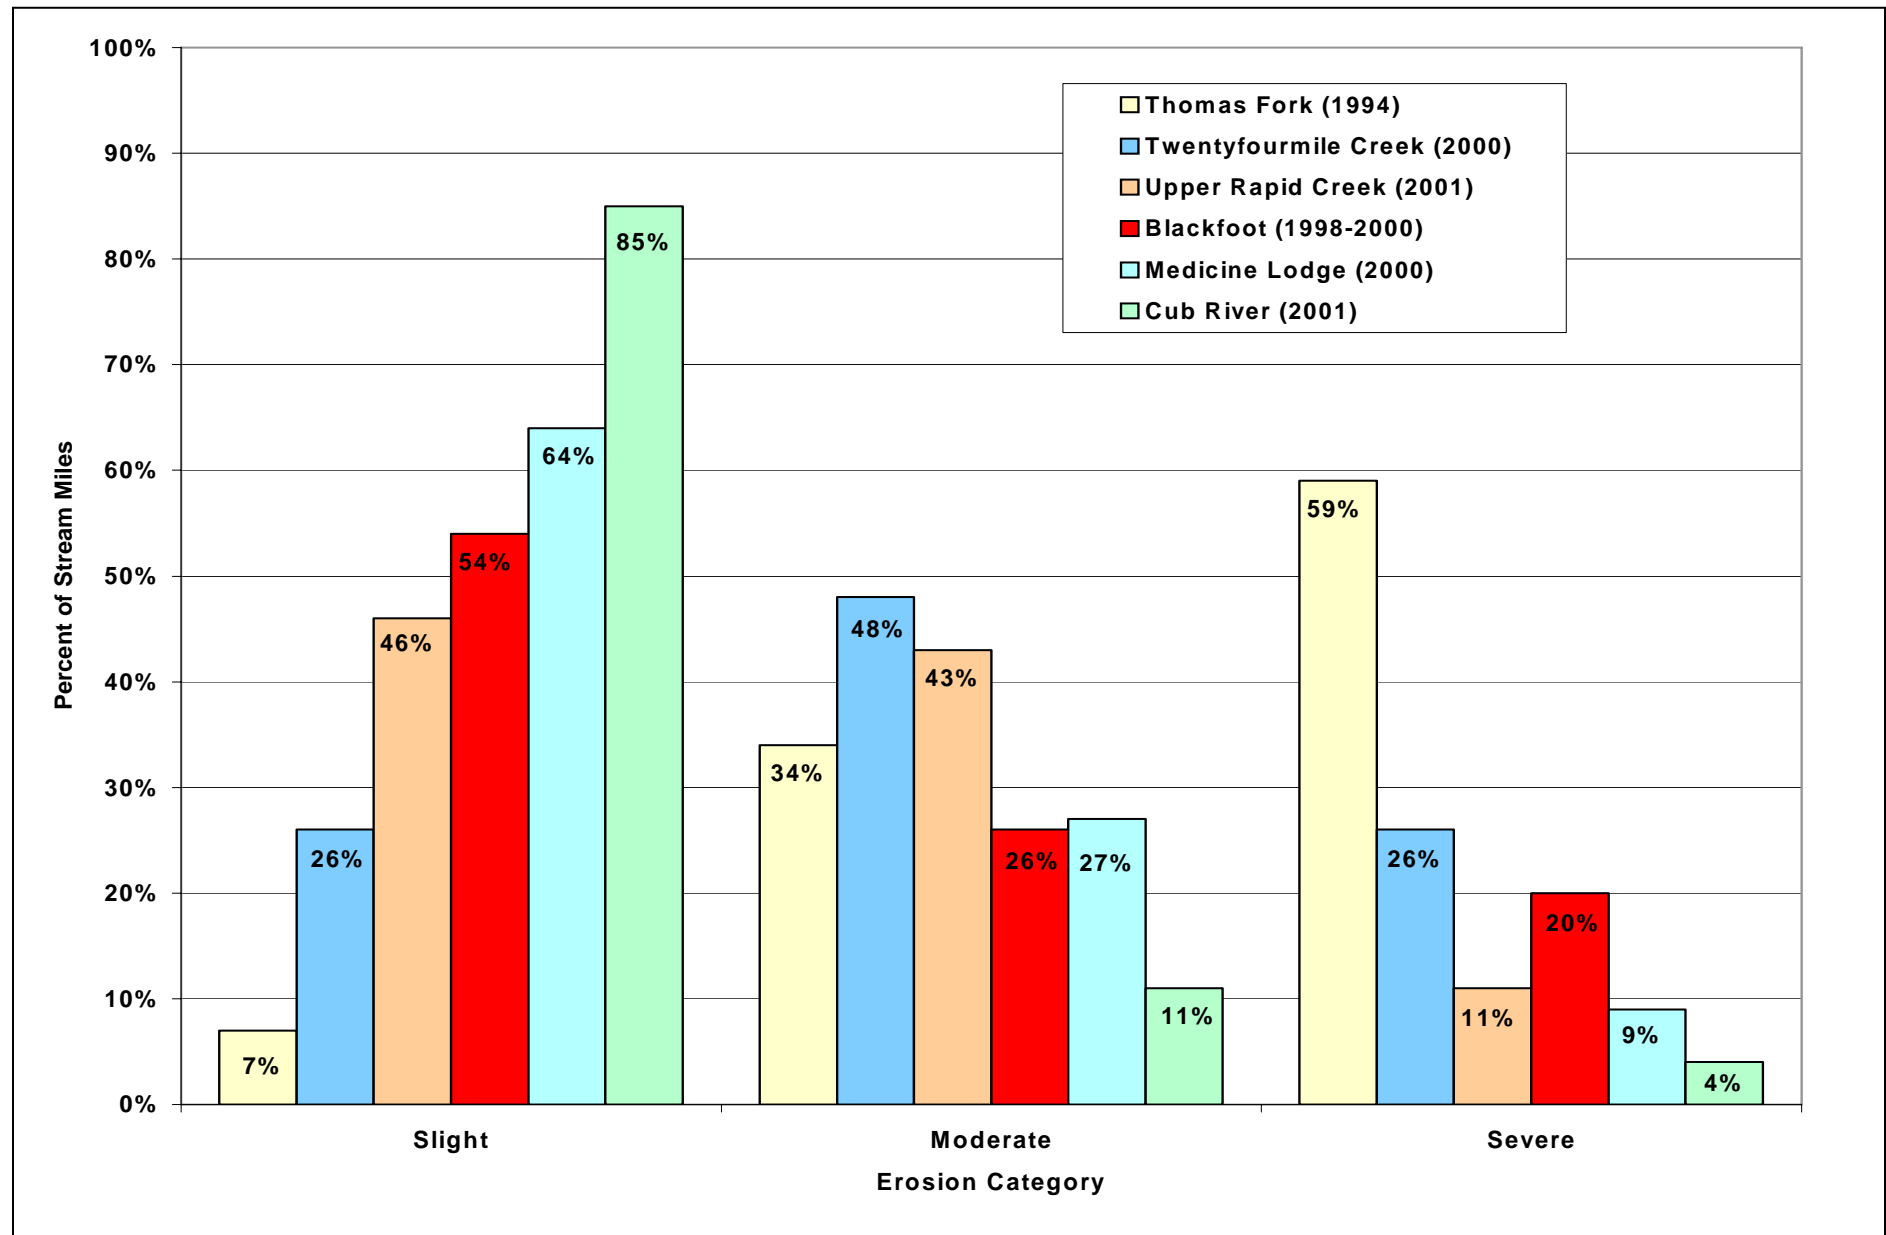
Figure 20. Comparison of Assessed Reaches in the Blackfoot River Subbasin and Eastern Idaho Watersheds
